**AGENDA FOR THE  
QUINTE CONSERVATION  
EXECUTIVE BOARD MEETING**

**Date: April 18, 2024**

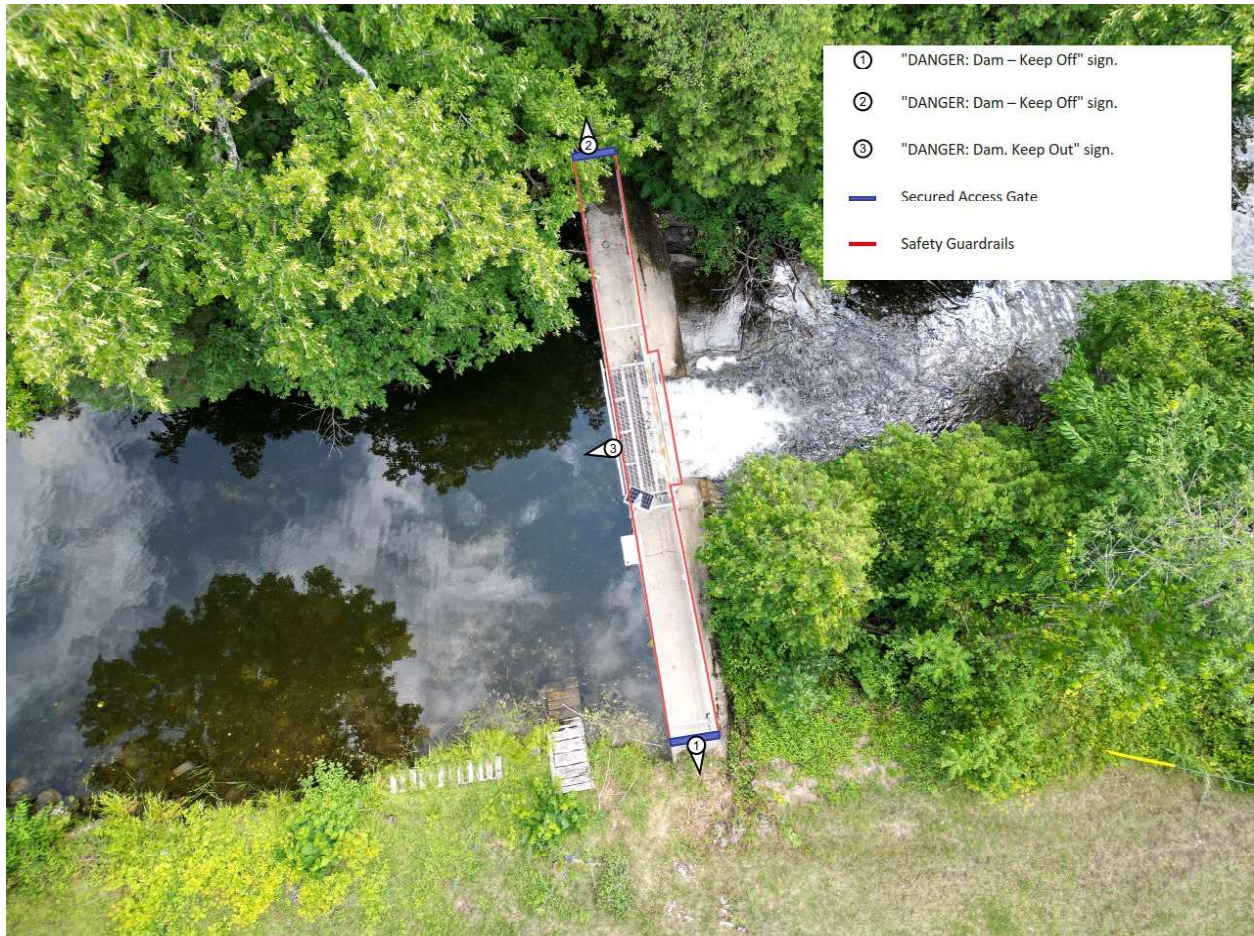
**FIGURE 2-2: GENERAL LAYOUT OF UPPER ARDEN DAM SAFETY MEASURES**

Structure/Component		Deficiencies/Issues			Recommendation			Priority Level	Action Type	Cost <sup>1/</sup>
<b>Hydrotechnical Aspects</b>										
<b>Freeboard</b>		<ul style="list-style-type: none"> <li>The dam would be overtopped during passage of the IDF by approximately 2 m. It is possible that the IDF can be reduced. In parallel, the seismic AEP can be re-evaluated.</li> </ul>	<ul style="list-style-type: none"> <li>Complete “incremental analysis” as per MINRF (2011) to investigate if a lower IDF than the flood 1/3 of the way between the 1,000-year and the PMF can be adopted. The analysis can include a confirmation of the HPC for flood-induced as well as for sunny-day failures and allow adjustment of dam safety criteria for this dam.</li> </ul>	<ul style="list-style-type: none"> <li>Medium</li> </ul>	<ul style="list-style-type: none"> <li>Study</li> </ul>	<ul style="list-style-type: none"> <li>\$25,000</li> </ul>

<b>Geotechnical Aspects</b>										
<b>Concrete Condition</b>	<ul style="list-style-type: none"> <li>The original concrete was observed to be composed of poorly graded concrete infill between large boulders up to 500 mm in size.</li> <li>Cracked and disjointed poor condition concrete beneath the surface of the dam.</li> </ul>	<ul style="list-style-type: none"> <li>Complete additional core hole investigations to confirm the feasibility of post-tensioned anchors and to determine the need for injection grouting.</li> </ul>	<ul style="list-style-type: none"> <li>High</li> </ul>	<ul style="list-style-type: none"> <li>Investigation</li> </ul>	<ul style="list-style-type: none"> <li>\$30,000</li> </ul>					
<b>Foundation</b>	<ul style="list-style-type: none"> <li>Localized water boiling area immediately downstream of the dam adjacent to the south shoreline (leakage through base of dam)</li> </ul>	<ul style="list-style-type: none"> <li>Continue monitoring the downstream boiling area until the remediation measures are undertaken.</li> <li>Complete technical specifications and drawings via qualified engineer and carry out the repair of the leakage through the base of the dam.</li> </ul>	<ul style="list-style-type: none"> <li>N/A</li> <li>Medium</li> </ul>	<ul style="list-style-type: none"> <li>Monitoring</li> <li>Repair</li> </ul>	<ul style="list-style-type: none"> <li>By QC</li> <li>\$75,000</li> </ul>

<b>Structural Aspects</b>										
<b>Abutment and Overflow Weir Sections</b>	<ul style="list-style-type: none"> <li>Dam does not currently meet the requirements of the 2011 MINRF Guidelines for the Winter Usual, Winter Unusual, IDF or Earthquake Loading cases.</li> </ul>	<ul style="list-style-type: none"> <li>Install post-tensioned anchors on the abutments of the dam to provide the required stability under all loading conditions. The feasibility of post-tensioned anchor and the need of injection grouting shall be confirmed by core hole sampling and further investigation on existing concrete quality.</li> </ul>	<ul style="list-style-type: none"> <li>High</li> </ul>	<ul style="list-style-type: none"> <li>Repair</li> </ul>	<ul style="list-style-type: none"> <li>\$600,000</li> </ul>					
<b>Concrete Condition</b>	<ul style="list-style-type: none"> <li>Medium vertical crack on north abutment section extending from upstream face, over crest and down approximately 1.5 m on downstream face of dam</li> </ul>	<ul style="list-style-type: none"> <li>Complete technical specifications and drawings via qualified engineer to perform crack injection to prolong the service life of the dam.</li> </ul>	<ul style="list-style-type: none"> <li>Medium</li> </ul>	<ul style="list-style-type: none"> <li>Repair</li> </ul>	<ul style="list-style-type: none"> <li>\$20,000</li> </ul>

<b>Public/Operator Safety Aspects</b>										
<b>Safety Booms</b>	<ul style="list-style-type: none"> <li>No safety booms are present upstream of the dam</li> </ul>	<ul style="list-style-type: none"> <li>It is a good practice to install safety booms to delineate the dangerous water area as recommended by the MINRF guidelines.</li> <li>As an interim measure, it is recommended to monitor the type and frequency of public activities in the hazardous zone immediately upstream of the dam and implement safety measures as needed (e.g. no swimming signage, no fishing signage, public education, etc.)</li> </ul>	<ul style="list-style-type: none"> <li>Medium</li> <li>Medium</li> </ul>	<ul style="list-style-type: none"> <li>Repair</li> <li>Monitoring</li> </ul>	<ul style="list-style-type: none"> <li>\$210,000</li> <li>By QC</li> </ul>

The Upper Arden Dam, located along Arden Creek between Big Clear Lake and Arden Lake, is owned and operated by the Quinte Conservation. The construction date of the Upper Arden Dam is unknown. The dam is a concrete structure, 1.8 meters high, and 14.9 meters long. It features a stoplog sluice with six removable stop logs, flanked by a gravity abutment section to either side. The crest of the dam is 1.1 meters wide. Its main functions are maintaining Big Clear Lake water level for recreation purposes, to supply drinking water for the Arden Town residents, and attenuate floods during high flow events.

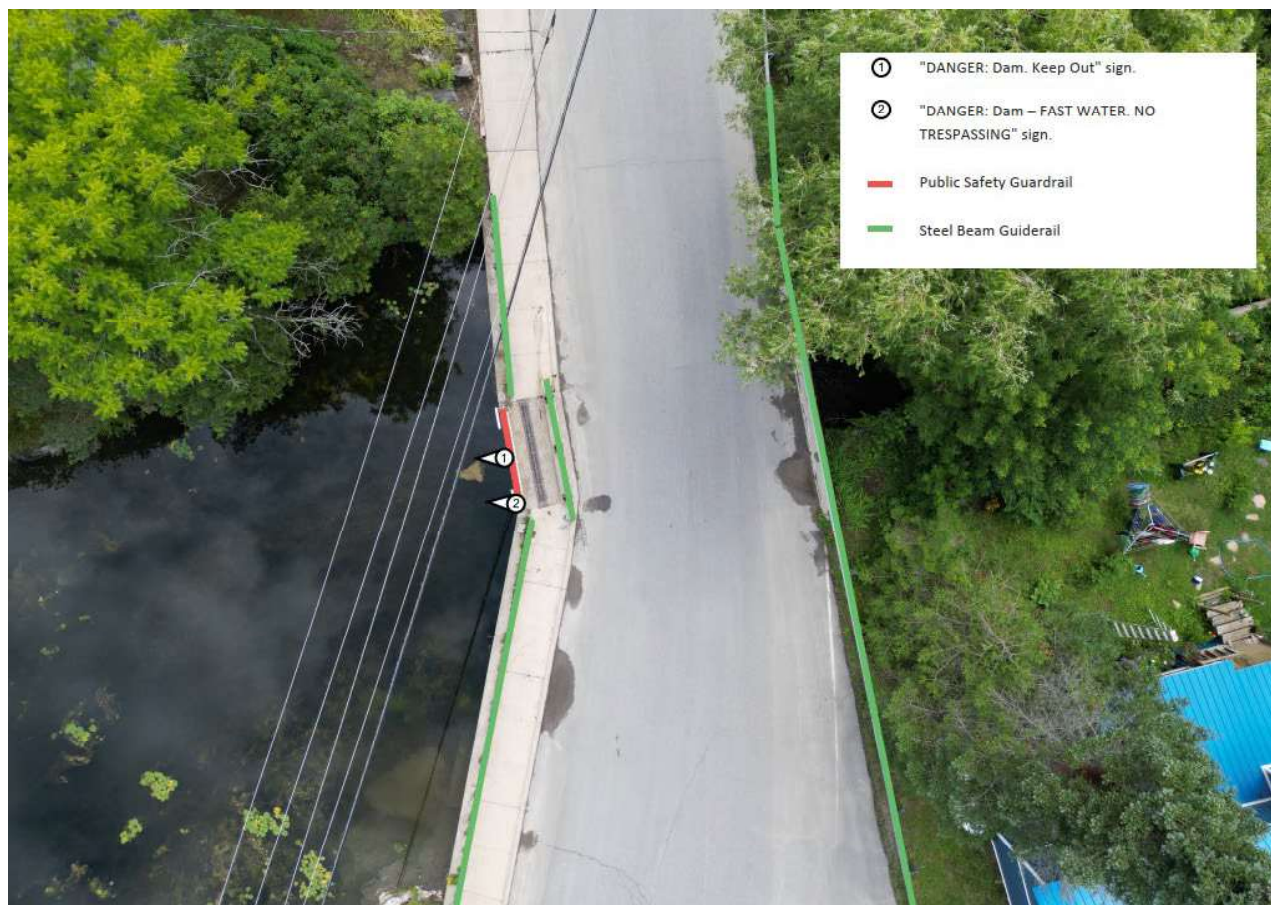
**FIGURE 2-2: GENERAL LAYOUT OF MIDDLE ARDEN DAM SAFETY MEASURES**

Structure/Component	Deficiencies/Issues	Recommendation	Priority Level	Action Type	Cost /U
<b>Hydrotechnical Aspects</b>					
<b>Freeboard</b>	<ul style="list-style-type: none"> <li>Although the freeboard is adequate, the dam has additional capacity, not fully utilized during floods. This is not considered a deficiency but, rather, an opportunity for improvement.</li> </ul>	<ul style="list-style-type: none"> <li>It is advisable to confirm if flood forecasting can be improved or if the dam can be operated during a flood.</li> </ul>	<ul style="list-style-type: none"> <li>Low</li> </ul>	<ul style="list-style-type: none"> <li>Study</li> </ul>	<ul style="list-style-type: none"> <li>\$15,000</li> </ul>
	<ul style="list-style-type: none"> <li>Depressions and uneven areas on upstream slope</li> </ul>	<ul style="list-style-type: none"> <li>Complete technical specifications via qualified engineer to carry out filling and regrading of the depressions and uneven areas on the upstream slope.</li> <li>Continue monitoring the depressions until the remediation work has been completed.</li> <li>Continue monitoring the upstream slope to observe any recurring depressions after the remediation work has been completed.</li> </ul>	<ul style="list-style-type: none"> <li>Medium</li> <li>N/A</li> <li>N/A</li> </ul>	<ul style="list-style-type: none"> <li>Repair</li> <li>Monitoring</li> <li>Monitoring</li> </ul>	<ul style="list-style-type: none"> <li>\$15,000</li> <li>By QC</li> <li>By QC</li> </ul>

Structure/Component	Deficiencies/Issues	Recommendation	Priority Level	Action Type	Cost <sup>1/1</sup>
<b>South Downstream Armour Stone Retaining Wall</b>	<ul style="list-style-type: none"> <li>The armour stone retaining wall is in poor condition with large gaps between stones and misaligned stones with overhanging.</li> <li>The armour stone retaining wall retains the backfill material of Arden Road.</li> </ul>	<ul style="list-style-type: none"> <li>Complete technical specifications via qualified engineer to carry out the repair/replacement of the armour stone retaining wall.</li> <li>Continue monitoring the armour stone retaining wall until the remediation work has been completed.</li> </ul>	<ul style="list-style-type: none"> <li>Medium</li> <li>N/A</li> </ul>	<ul style="list-style-type: none"> <li>Repair</li> <li>Monitoring</li> </ul>	<ul style="list-style-type: none"> <li>\$25,000</li> <li>By QC</li> </ul>

<b>Structural Aspects</b>				
<b>Concrete Condition</b>	<ul style="list-style-type: none"> <li>Concrete curb on upstream and downstream end of traffic deck in poor condition due to cracking and spalling</li> </ul>	<ul style="list-style-type: none"> <li>Remove and replace existing concrete curbs with new concrete.</li> </ul>	<ul style="list-style-type: none"> <li>Low</li> </ul>	<ul style="list-style-type: none"> <li>Repair</li> </ul>	<ul style="list-style-type: none"> <li>\$15,000</li> </ul>
<b>Stoplog Jacking System</b>	<ul style="list-style-type: none"> <li>Current practice to apply jacking force to stoplogs may result in excessive stress to culvert top deck</li> </ul>	<ul style="list-style-type: none"> <li>Install a jacking pin system to reduce stress on the deck</li> <li>Do not over-jack during stoplog operation</li> </ul>	<ul style="list-style-type: none"> <li>Low</li> </ul>	<ul style="list-style-type: none"> <li>Repair</li> </ul>	<ul style="list-style-type: none"> <li>\$65,000</li> </ul>

<b>Public/Operator Safety Aspects</b>					
<b>Safety Booms</b>	<ul style="list-style-type: none"> <li>No safety booms are present upstream of the dam</li> </ul>	<ul style="list-style-type: none"> <li>It is a good practice to install safety booms to delineate the dangerous water area as recommended by the MNRF guidelines.</li> <li>As an interim measure, it is recommended to monitor the type and frequency of public activities in the hazardous zone immediately upstream of the dam and implement safety measures as needed (e.g. no swimming signage, no fishing signage, public education, etc.)</li> </ul>	<ul style="list-style-type: none"> <li>Low</li> <li>Medium</li> </ul>	<ul style="list-style-type: none"> <li>Repair</li> <li>Monitoring</li> </ul>	<ul style="list-style-type: none"> <li>\$230,000</li> <li>By QC</li> </ul>
<b>Guardrails</b>	<ul style="list-style-type: none"> <li>Existing guardrails located on upstream wingwalls/retaining walls are designed for vehicular safety and do not meet the standards for public safety.</li> </ul>	<ul style="list-style-type: none"> <li>Install public safety guardrails along the public walkways on the upstream side of the dam. Relocate vehicular guide rails between the roadway and sidewalk.</li> </ul>	<ul style="list-style-type: none"> <li>Low</li> </ul>	<ul style="list-style-type: none"> <li>Repair</li> </ul>	<ul style="list-style-type: none"> <li>\$30,000</li> </ul>

The Middle Arden Dam, located along Arden Creek between Big Clear Lake and Arden Lake, is owned and operated by Quinte Conservation. The Middle Arden Dam is approximately 45 meters downstream of the Upper Arden Dam. It consists of the Arden Road culvert, equipped with 12 stoplogs. The culvert dimensions are 3 meters high, 3 meters wide, and 8 meters long. Its main function is to maintain water in a small pond for recreational uses, and to supply drinking water for the Arden Town residents.

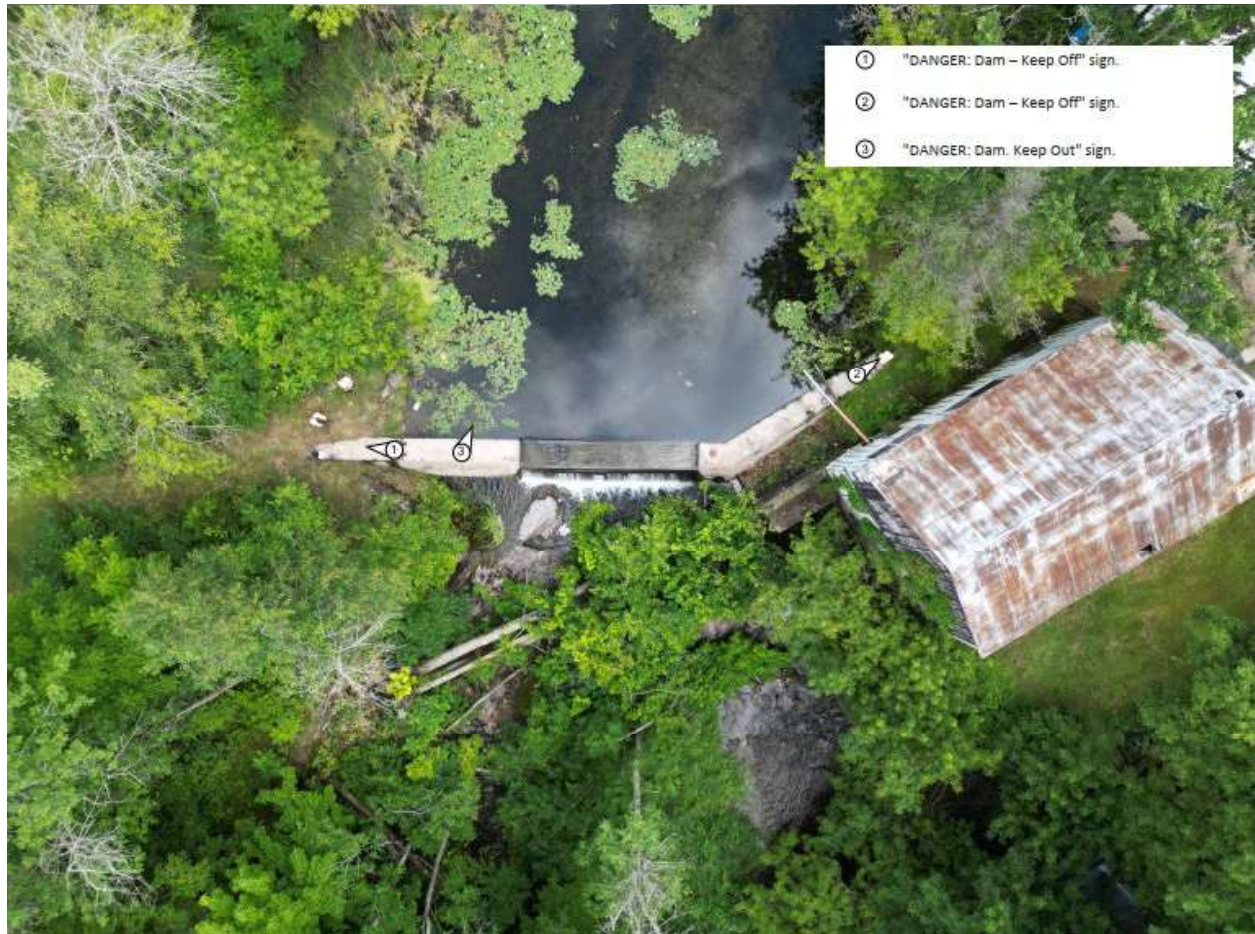
**FIGURE 2-2: GENERAL LAYOUT OF LOWER ARDEN DAM SAFETY MEASURES**

Structure/Component	Deficiencies/Issues	Recommendation	Priority Level	Action Type	Costs <sup>/1/</sup>
<b>Geotechnical Aspects</b>					
<b>Abutments</b>	<ul style="list-style-type: none"> <li>No immediate deficiencies/issues</li> </ul>	<ul style="list-style-type: none"> <li>Monitor the north and south abutment tie-in contacts for any seepage or deterioration of the concrete</li> </ul>	<ul style="list-style-type: none"> <li>N/A</li> </ul>	<ul style="list-style-type: none"> <li>Monitoring</li> </ul>	<ul style="list-style-type: none"> <li>By QC</li> </ul>
<b>South Upstream Shoreline</b>	<ul style="list-style-type: none"> <li>Minor surface erosion</li> </ul>	<ul style="list-style-type: none"> <li>Monitor any progression of the minor surface erosion at the south upstream shoreline close to the south abutment contact</li> </ul>	<ul style="list-style-type: none"> <li>N/A</li> </ul>	<ul style="list-style-type: none"> <li>Monitoring</li> </ul>	<ul style="list-style-type: none"> <li>By QC</li> </ul>

<b>Concrete Condition</b>	<ul style="list-style-type: none"> <li>Open cracks subject to erosion at either side of the overflow section</li> </ul>	<ul style="list-style-type: none"> <li>Prepare drawings and technical specifications by qualified engineer for crack injection program to prolong the service life of the dam</li> </ul>	<ul style="list-style-type: none"> <li>Low</li> </ul>	<ul style="list-style-type: none"> <li>Repair</li> </ul>	<ul style="list-style-type: none"> <li>\$15,000</li> </ul>
<b>Debris Management Downstream of Dam</b>	<ul style="list-style-type: none"> <li>Large fallen tree and heavy vegetation immediately downstream of overflow weir section</li> </ul>	<ul style="list-style-type: none"> <li>Clear the vegetation and debris and establish maintenance procedure to avoid future impact to the dam</li> </ul>	<ul style="list-style-type: none"> <li>Low</li> </ul>	<ul style="list-style-type: none"> <li>Repair</li> </ul>	<ul style="list-style-type: none"> <li>\$8,000</li> </ul>

<b>Public/Operator Safety Aspects</b>					
<b>Safety Booms</b>	<ul style="list-style-type: none"> <li>No safety booms are present upstream of the dam</li> </ul>	<ul style="list-style-type: none"> <li>It is a good practice to install safety booms to delineate the dangerous water area as recommended by the MNRF guidelines.</li> </ul>	<ul style="list-style-type: none"> <li>Low</li> </ul>	<ul style="list-style-type: none"> <li>Repair</li> </ul>	<ul style="list-style-type: none"> <li>\$210,000</li> </ul>
<b>Guardrails / Gate</b>	<ul style="list-style-type: none"> <li>No gate or guardrail exists at the accessible areas of the dam</li> </ul>	<ul style="list-style-type: none"> <li>As an interim measure, it is recommended to monitor the type and frequency of public activities in the hazardous zone immediately upstream of the dam and implement safety measures as needed (e.g. no swimming signage, no fishing signage, public education, etc.)</li> <li>Monitor the dam for trespassing, and in case of incident(s) consider installation of a secured gate and guardrails for the accessible areas.</li> </ul>	<ul style="list-style-type: none"> <li>Medium</li> </ul>	<ul style="list-style-type: none"> <li>Monitor</li> </ul>	<ul style="list-style-type: none"> <li>By QC</li> </ul>

The Lower Arden Dam, located along Arden Creek between Big Clear Lake and Arden Lake, is owned and operated by Quinte Conservation. The dam is an old mill dam situated approximately 150 meters downstream of the Middle Arden Dam. The main function of the dam was originally to provide waterpower to the adjacent mill, which is no longer operational. Currently, the dam maintains water in a small head pond for limited recreational use and for water supply. The Lower Arden Dam is a concrete structure, 2.75 meters high, and 25.5 meters long. The crest of the dam is 0.92 meters wide. Water discharges over the dam via an uncontrolled 7.6 meters long and 0.75 meters high spillway. The dam is not operated and the continuous discharge over the spillway is being maintained by the operation of the Upper Arden Dam and Middle Arden Dam.

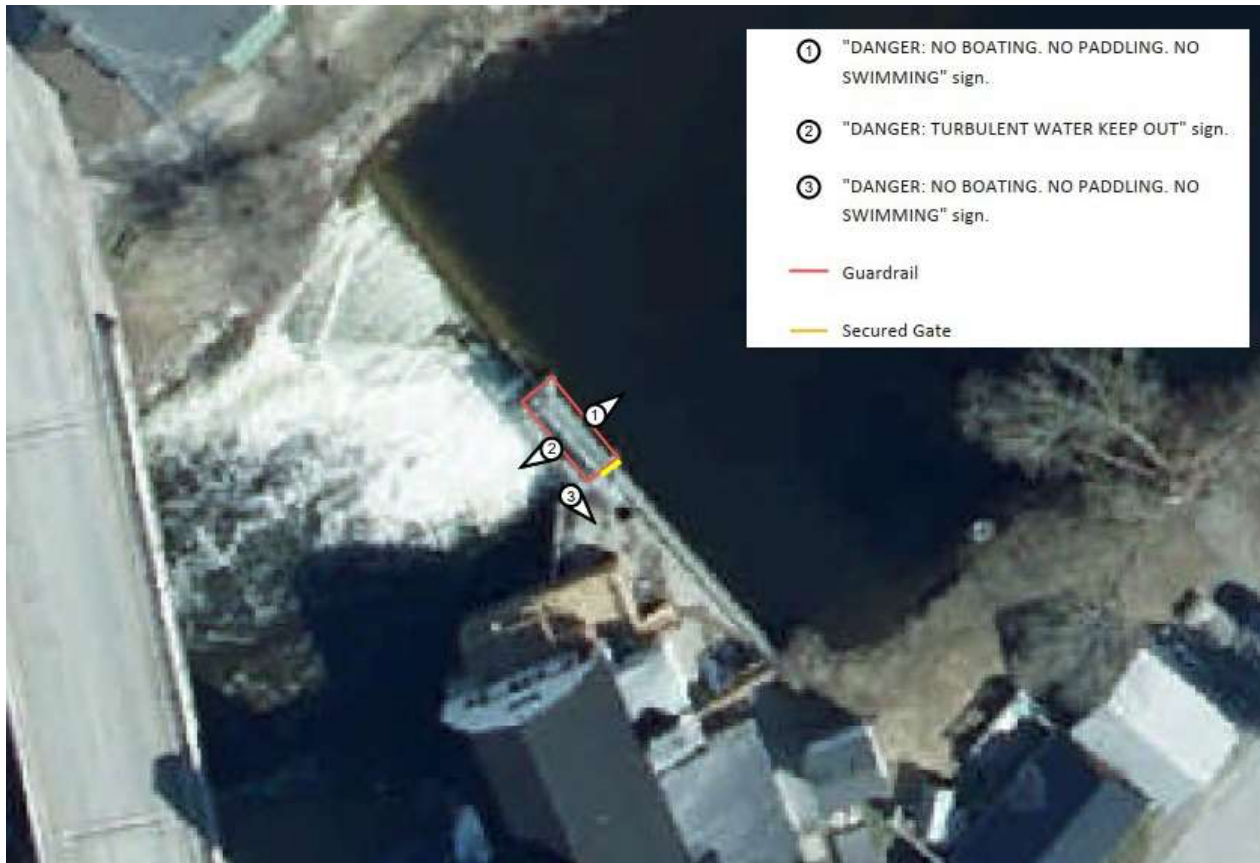
**FIGURE 2-2: LAYOUT OF CONSECON MILL DAM SAFETY MEASURES**

Structure/Component	Deficiencies/Issues	Recommendation	Priority Level	Action Type	Cost
<b>Geotechnical Aspects</b>					
<b>Overflow Weir</b>	<ul style="list-style-type: none"> <li>Undermined area beneath low-flow overflow weir section</li> </ul>	<ul style="list-style-type: none"> <li>Complete technical specifications via qualified engineer and carry out the repair of the undermined area during no-flow conditions using concrete/grout</li> <li>Continue monitoring the undermined area during no-flow conditions until the remedial work has been completed</li> <li>Monitor the concrete-to-bedrock contact along the length of the overflow weir for any seepage, erosion, instability failures, or back-cutting at the toe of the overflow weir structure</li> </ul>	<ul style="list-style-type: none"> <li>High</li> <li>N/A</li> <li>N/A</li> </ul>	<ul style="list-style-type: none"> <li>Repair</li> <li>Monitoring</li> <li>Monitoring</li> </ul>	<ul style="list-style-type: none"> <li>\$25K</li> <li>By QC</li> <li>By QC</li> </ul>

<b>South Upstream Retaining Wall Abutment</b>	<ul style="list-style-type: none"> <li>Minor surface erosion at the south upstream retaining wall abutment contact</li> </ul>	<ul style="list-style-type: none"> <li>Install properly sized additional rip-rap protection at the upstream abutment contact (up to 3 m upstream)</li> </ul>	<ul style="list-style-type: none"> <li>Medium</li> </ul>	<ul style="list-style-type: none"> <li>Maintenance</li> </ul>	<ul style="list-style-type: none"> <li>\$10K</li> </ul>
<b>North Abutment</b>	<ul style="list-style-type: none"> <li>No immediate deficiencies/issues</li> </ul>	<ul style="list-style-type: none"> <li>Monitor the north abutment tie-in contacts for any seepage or deterioration of the concrete/interlocking concrete blocks</li> </ul>	<ul style="list-style-type: none"> <li>N/A</li> </ul>	<ul style="list-style-type: none"> <li>Monitoring</li> </ul>	<ul style="list-style-type: none"> <li>By QC</li> </ul>

<b>Vegetation</b>	<ul style="list-style-type: none"> <li>Bush/small tree vegetation growing at the north and south abutment contacts</li> </ul>	<ul style="list-style-type: none"> <li>Remove any substantial bush/tree growth from the abutment contacts up to 4 m in both the upstream and downstream directions</li> </ul>	<ul style="list-style-type: none"> <li>Medium</li> </ul>	<ul style="list-style-type: none"> <li>Maintenance</li> </ul>	<ul style="list-style-type: none"> <li>By QC</li> </ul>
<b>Structural Aspects</b>					
<b>Access Stairway</b>	<ul style="list-style-type: none"> <li>Crack along length of stairway</li> </ul>	<ul style="list-style-type: none"> <li>Replacing the stairway with a steel access stairway.</li> </ul>	<ul style="list-style-type: none"> <li>Medium</li> </ul>	<ul style="list-style-type: none"> <li>Repair</li> </ul>	<ul style="list-style-type: none"> <li>\$30k</li> </ul>
<b>Walkway Slab</b>	<ul style="list-style-type: none"> <li>High amount of water ponding due to poor drainage</li> </ul>	<ul style="list-style-type: none"> <li>Cut drainage outlet trough(s) at the top of the downstream retaining wall near the low point of the walkway slab to allow water ponding to flow downstream.</li> </ul>	<ul style="list-style-type: none"> <li>Low</li> </ul>	<ul style="list-style-type: none"> <li>Repair</li> </ul>	<ul style="list-style-type: none"> <li>\$5k</li> </ul>

<b>Spillway Pier and Overflow Weir</b>	<ul style="list-style-type: none"> <li>Both overflow weir and spillway pier do not currently meet the requirements of the 2011 MNRF Guidelines for the Winter Usual or Unusual Loading cases.</li> </ul>	<ul style="list-style-type: none"> <li>Monitor the dam winter ice loading conditions and determine if an ice sheet is formed in the dam forebay, and if the ice sheet effectively bridges from the south to the north pier.</li> <li>Inspect the dam for damage/movement from ice impacts. If any distress of the dam is identified, consult an engineer to assess if additional stability measures are required.</li> </ul>	<ul style="list-style-type: none"> <li>High</li> </ul>	<ul style="list-style-type: none"> <li>Monitoring</li> </ul>	<ul style="list-style-type: none"> <li>By QC</li> </ul>
<b>Public/Operator Safety Aspects</b>					
<b>Safety Booms</b>	<ul style="list-style-type: none"> <li>No safety booms located upstream of the dam</li> </ul>	<ul style="list-style-type: none"> <li>It is a good practice to install safety booms to delineate the dangerous water area as recommended by the MNRF guidelines.</li> </ul>	<ul style="list-style-type: none"> <li>Medium</li> </ul>	<ul style="list-style-type: none"> <li>Repair</li> </ul>	<ul style="list-style-type: none"> <li>\$250k</li> </ul>

<b>"Danger" Upstream Signage</b>	<ul style="list-style-type: none"> <li>"DANGER" upstream sign is not appropriately sized to read from a safe distance from the hazardous area and does not meet MNRF's recommended color scheme.</li> </ul>	<ul style="list-style-type: none"> <li>As an interim measure, it is recommended to monitor the type and frequency of public activities in the hazardous zone immediately upstream of the dam and implement safety measures as needed (e.g. no swimming signage, no fishing signage, public education, etc.)</li> <li>Consider replacement of the sign with a standard 4' x 6' MNRF signage design using red and white lettering and indicate that the public must keep out of the hazardous zone.</li> </ul>	<ul style="list-style-type: none"> <li>Medium</li> <li>Low</li> </ul>	<ul style="list-style-type: none"> <li>Monitoring</li> <li>Repair</li> </ul>	<ul style="list-style-type: none"> <li>By QC</li> <li>\$2k</li> </ul>

<p><b>“No Trespassing” Signage</b></p>	<ul style="list-style-type: none"> <li>Lack of “No Trespassing” signage to deter public from approach the access stairway south of the operations deck.</li> </ul>	<ul style="list-style-type: none"> <li>Install new “No Trespassing” sign at the access gate to the operations deck, facing the public patio area.</li> </ul>	<ul style="list-style-type: none"> <li>Low</li> </ul>	<ul style="list-style-type: none"> <li>Repair</li> </ul>	<ul style="list-style-type: none"> <li>\$1k</li> </ul>
--	--	--	---	--	--

Consecun Mill Dam, located across the Consecun Creek, in the village of Consecun, Ontario, is owned and operated by Quinte Conservation. The main storage feature along the creek is Consecun Lake. Below the Whitney Dam and upstream of Regional Rd 29, there is a small reservoir formed by the Consecun Mill Dam. About 400 m downstream from the Consecun Mill Dam, the creek feeds into Wellers Bay, Lake Ontario.

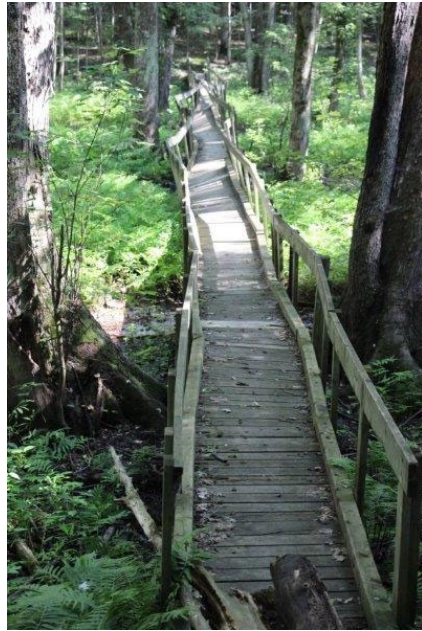
The previous Hi-Lo Bridge In Poor Condition Prior to Removal

The purpose of this project is to replace the original Hi-Lo Boardwalk which was removed by Quinte Conservation due to safety concerns. The new boardwalk will be better equipped to handle the required water and ice flows by using galvanized helical piles for a foundation in lieu of cedar cribs and by placing the boardwalk above the 100-year regulatory flood event. When compared to other installation methods the helical piles provide much better stability and bearing capacity while also minimizing damage to the wetland area.

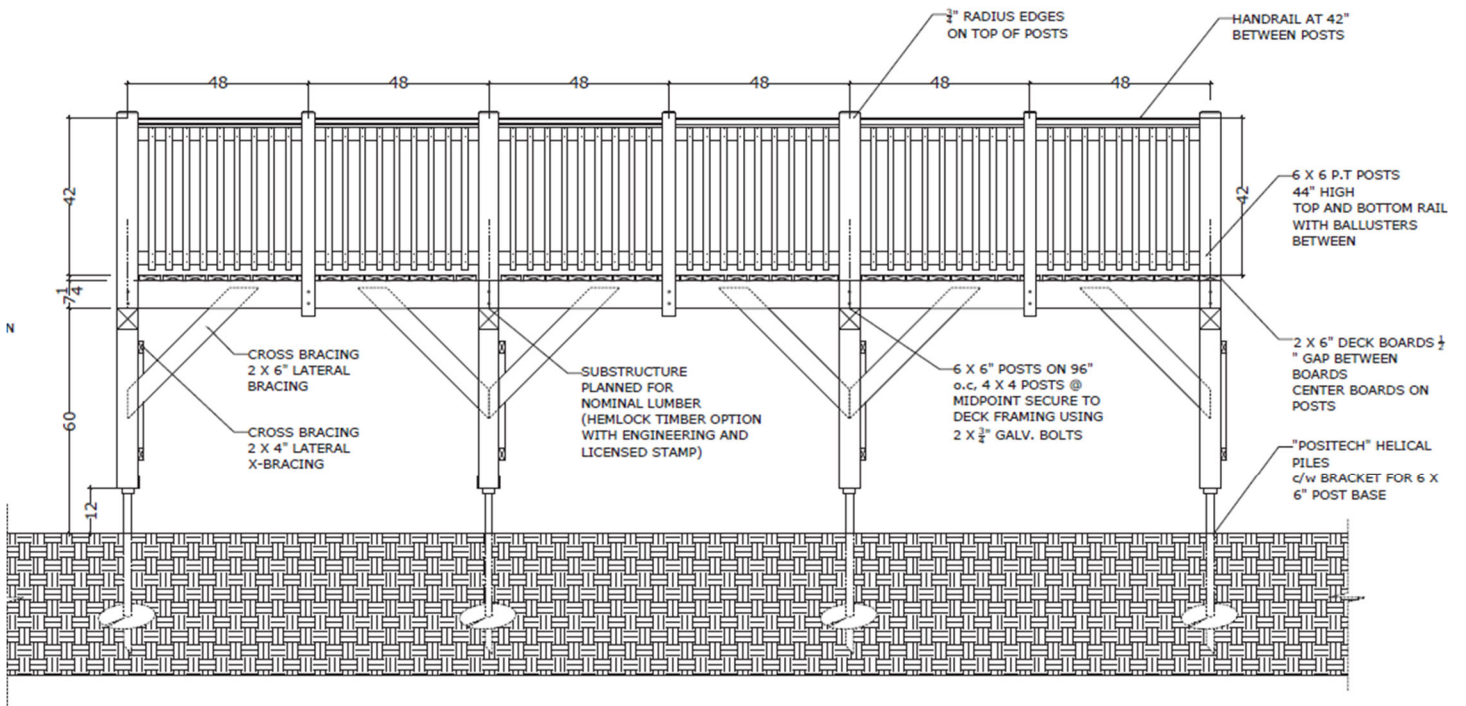
Conceptual Drawing – Ducon Contractors and Homes Ltd. Proposal, Mar 2024

<b>Contractor</b>	<b>Design Price</b>	<b>Construction Budget</b>	<b>Foundation Style</b>
Company A	\$17,800.00	\$99,654.86	Direct Buried Wood Support
Ducon Contractor and Homes Ltd.	\$7,500.00	\$151,378.84	Helical Pile – 12” above grade. Cross bracing to be 2x6 PT.
Company C	\$8,500.00	\$223,000.00	Helical Pile – to underside of joist. Pile system includes cross bracing.

Quinte Conservation has reviewed, approved and witnessed the installation of similar helical piles for boardwalks through our permitting office. Given the above, Quinte Conservation recommends that we issue a contact for \$7,500 to Ducon Contractors and Homes Ltd. for the design of the Hi-Lo Boardwalk with the option to increase the contract to include the construction.
